**Flood Control Project Maintenance
Levee Inspections**
LMA District Cover Sheet
Spring 2017 Levee Inspection Results

Sutter Maintenance Yard Tisdale Bypass

Waterway			Bank	Unit Miles
Unit No. 01 Tisdale Bypass			Left	4.51
	Spring (March - May)	Summer (June - August)	(September - November) Fall	Winter (December - February)
Unit Maintenance Rating (Fall Only)				
Date of Inspection	4/7/2017 - 4/7/2017			
DWR Inspector	Bob Duffey			
Accompanied By	Steve Beckley Sutter Maintenance Yard

Levee Inspection Report By Mile - Spring 2017

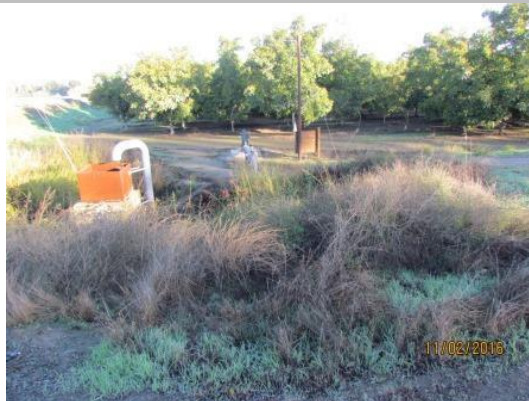
Photo 1 of 1 : SP_2017_ST0009_286_10_20170315_00002.jpg

LM Start	0.03	Rating **	M	Issue No.	10
LM End	0.03	Issue Type +	Ma	Location *	LS
Category	Earthen Levee			GPS Latitude/Longitude	
				Start	End
Item	Vegetation			39.027253 °	39.027253 °
				-121.821330 °	-121.821330 °
DWR ID	DWR_ST0009_01_f_2016_10				
Comment Code					
V1 : Control annual grass and weeds on the levee slopes and easements.					
Inspector Comment

View of grass taller than 12 inches blocking visibility.

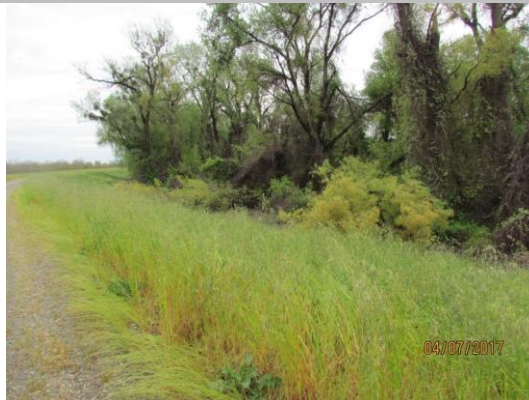
Photo 1 of 1 : SP_2017_ST0009_286_15_20170410_00017.jpg

View of the tree along the waterside slope and toe.

LM Start	0.21	Rating **	M	Issue No.	15
LM End	0.21	Issue Type +	En	Location *	WS
Category	Earthen Levee			GPS Latitude/Longitude	
				Start	End
Item	Encroachments			39.028143 °	39.028143 °
				-121.818090 °	-121.818090 °
DWR ID	DWR_ST0009_01_s_2017_15				
Comment Code					
TR : Tree or limb					
Inspector Comment					
Remove the tree from the waterside slope and toe.

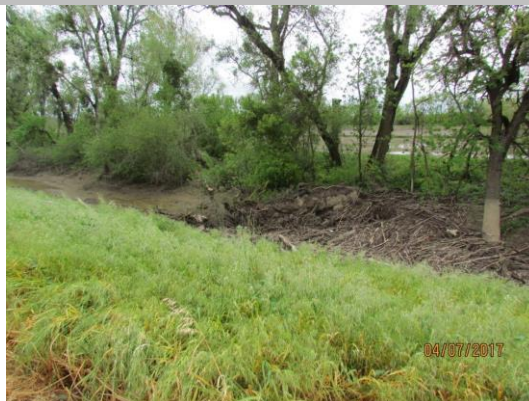
Photo 1 of 1 : SP_2017_ST0009_286_16_20170410_00019.jpg

View of the tree along the waterside slope and toe.

LM Start	1.28	Rating **	M	Issue No.	16
LM End	1.28	Issue Type +	En	Location *	CR
Category	Earthen Levee			GPS Latitude/Longitude	
				Start	End
Item	Encroachments			39.028265 °	39.028265 °
				-121.798370 °	-121.798370 °
DWR ID	DWR_ST0009_01_s_2017_16				
Comment Code					
TR : Tree or limb					
Inspector Comment					
Remove the tree from the waterside slope and toe.

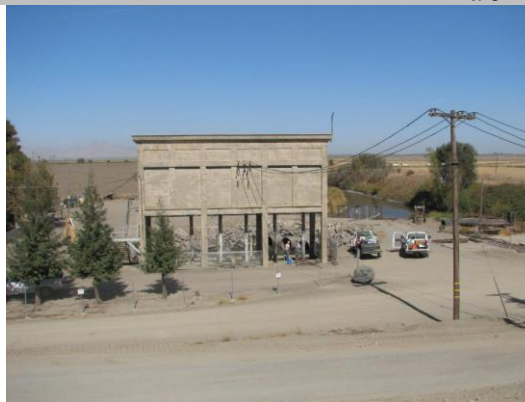
Photo 3 of 3 : UCIP_SP_2017_51484_64224.jpg

Pump house on LS toe.

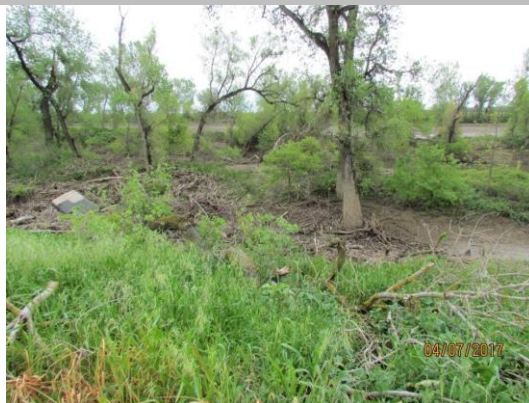
Photo 1 of 1 : SP_2017_ST0009_286_18_20170410_00023.jpg

View of the tree along the waterside slope and toe.

LM Start	2.62	Rating **	M	Issue No.	18
LM End	2.62	Issue Type +	En	Location *	WS
Category	Earthen Levee			GPS Latitude/Longitude	
				Start	End
Item	Encroachments			39.028080 °	39.028080 °
				-121.773442 °	-121.773442 °
DWR ID	DWR_ST0009_01_s_2017_18				
Comment Code					
TR : Tree or limb					
Inspector Comment					
Remove the tree from the waterside slope and toe.

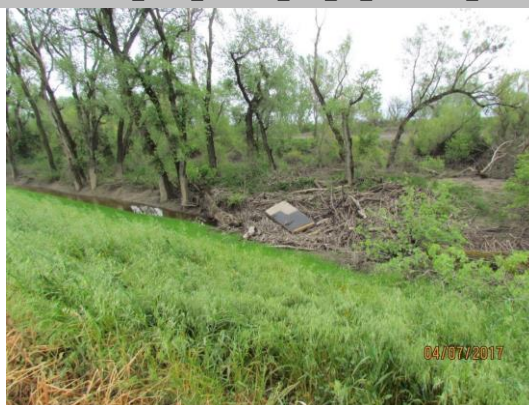
Photo 1 of 1 : SP_2017_ST0009_286_19_20170410_00021.jpg

View of the debris along the waterside slope and toe.

LM Start	2.62	Rating **	M	Issue No.	19
LM End	2.62	Issue Type +	En	Location *	WS
Category	Earthen Levee			GPS Latitude/Longitude	
				Start	End
Item	Encroachments			39.028080 °	39.028080 °
				-121.773442 °	-121.773442 °
DWR ID	DWR_ST0009_01_s_2017_19				
Comment Code					
DE : Debris					
Inspector Comment					
Remove the debris from the waterside slope and toe.

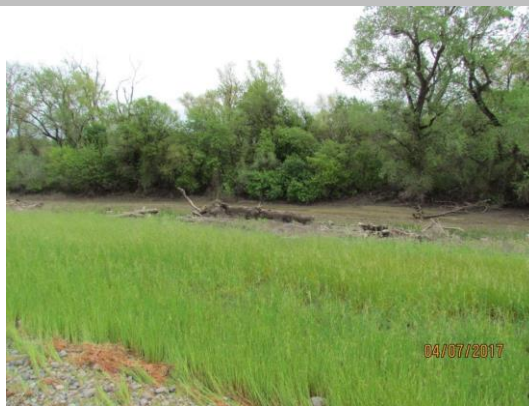
Photo 1 of 1 : SP_2017_ST0009_286_24_20170410_00024.jpg

View of the debris along the waterside slope and toe.

LM Start	4.35	Rating **	M	Issue No.	24
LM End	4.35	Issue Type +	En	Location *	WS
Category	Earthen Levee			GPS Latitude/Longitude	
				Start	End
Item	Encroachments			39.030637 °	39.030637 °
				-121.743023 °	-121.743023 °
DWR ID	DWR_ST0009_01_s_2017_24				
Comment Code					
DE : Debris					
Inspector Comment					
Remove the debris from the waterside slope and toe.

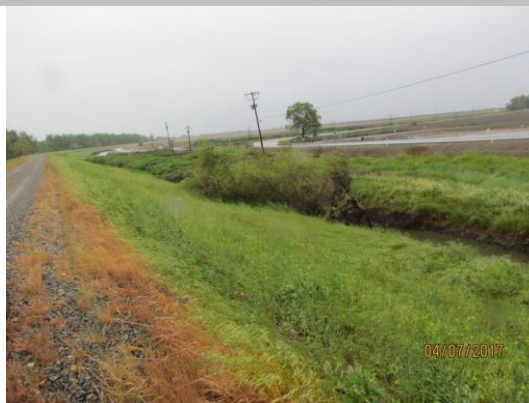
Photo 1 of 1 : SP_2017_ST0009_287_7_20170410_00014.jpg

View of the tree along landside slope and toe.

LM Start	0.13	Rating **	M	Issue No.	7
LM End	0.13	Issue Type +	En	Location *	LS
Category	Earthen Levee			GPS Latitude/Longitude	
				Start	End
Item	Encroachments			39.023973 °	39.023973 °
				-121.818467 °	-121.818467 °
DWR ID	DWR_ST0009_02_s_2017_7				
Comment Code					
TR : Tree or limb					
Inspector Comment					
Remove the tree from the landside slope and toe.

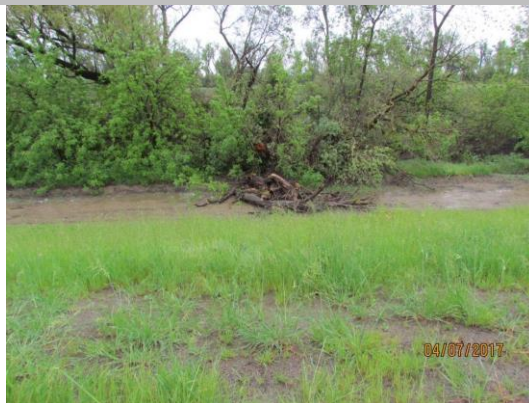
Photo 1 of 1 : SP_2017_ST0009_287_8_20170410_00015.jpg

View of the tree along the waterside slope and toe.

LM Start	0.45	Rating **	M	Issue No.	8
LM End	0.45	Issue Type +	En	Location *	WS
Category	Earthen Levee			GPS Latitude/Longitude	
				Start	End
Item	Encroachments			39.025635 °	39.025635 °
				-121.812975 °	-121.812975 °
DWR ID	DWR_ST0009_02_s_2017_8				
Comment Code					
TR : Tree or limb					
Inspector Comment					
Remove the tree from the waterside slope and toe.

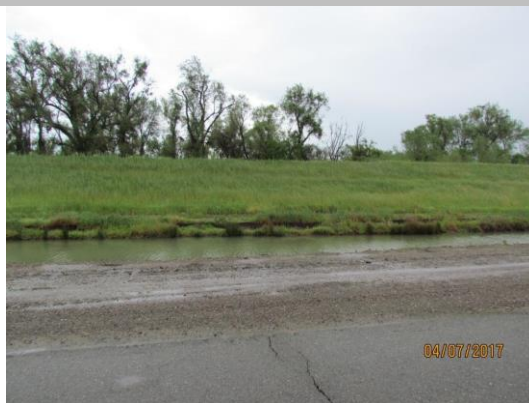
Photo 1 of 1 : SP_2017_ST0009_287_10_20170410_00017.jpg

View of the erosion along the landside toe from the County Road.

LM Start	0.97	Rating **	M	Issue No.	10
LM End	0.98	Issue Type +	Ma	Location *	LS
Category	Earthen Levee			GPS Latitude/Longitude	
				Start	End
Item	Erosion / Bank Caving			39.025540 °	39.025572 °
				-121.803272 °	-121.802990 °
DWR ID	DWR_ST0009_02_s_2017_10				
Comment Code					
E2 : Schedule repair of erosion site prior to the next inspection.					
Inspector Comment					
Repair the erosion along the landside toe.

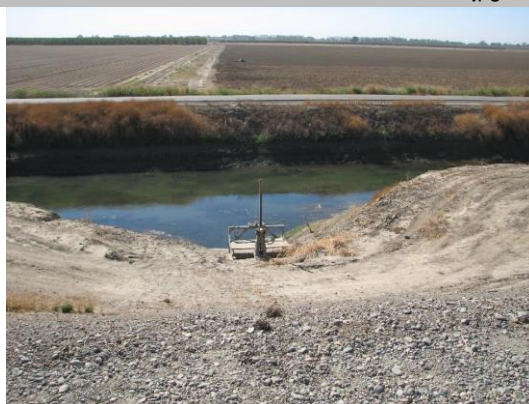
Photo 2 of 3 : UCIP_SP_2017_51489_64674.jpg

Slide gate at concrete outlet on LS toe.

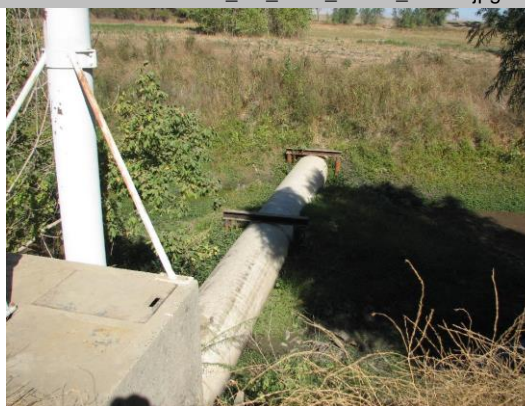
Photo 3 of 3 : UCIP_SP_2017_51489_64673.jpg

Item	DWR UCIP Field Study			39.025503 °		39.025503 °
				-121.800053 °		-121.800053 °
DWR ID						
Comment Code						
Inspector Comment						
FS_ID:51489 DS_ID:16594 EP_NO: 267 Repair Type: Urgent Crossing Status: Found UCIP Comments: 4/10/2017 Erosion appears to be getting worse at the WS vault. It is starting to erode away the WS toe road. (DWR Sutter Yard- A Freitag)10/11/2016 Erosion still present behind the WS vault.(DWR Sutter Yard - a Freitag)4/18/2016 Erosion happening around the WS concrete vault.5/7/2015 Burrowing near WS toe stil present.11/13/2014 Same as last inspection.5/12/2014 Same as last inspection.10/30/2013 Same as last inspection.5/20/2013 Same as last inspection.10/17/2012 Burrowing along downstream side of concrete vault on WS Toe. May need to be grouted. FIELD_STRUCT_DESC: 54-inch reinforced concrete irrigation pipe through the levee, 29.5 feet below the crown. Slide gates on both waterside (WS) and landside (LS) ends. WS end gate in 5-foot by 6-foot concrete box. LS end gate in concrete "U" headwall. Siphon pipe under and across bypass, steel concrete encased. (Permit No. 267 & 290 - Sutter Basin Water Co.) [Additional Reference(s): DWR Levee Log, 1993. USACE Sacramento O&M Manual 129, August 1955 (Station 61+25)]. FS Date: 4/12/2017 9:26:22 AM

Concrete box, vent, and 54-inch steel pipe in WS toe.

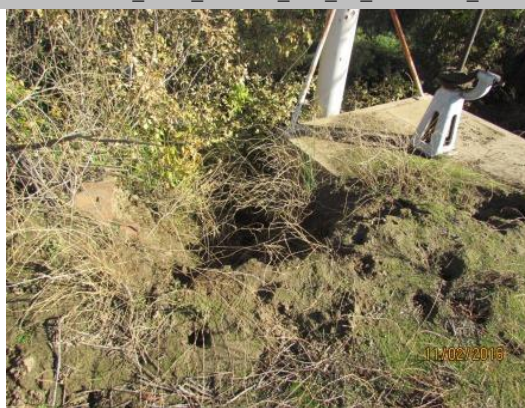
Photo 1 of 2 : SP_2017_ST0009_287_13_20170315_00005.jpg

LM Start	1.14	Rating **	M	Issue No.	13
LM End	1.14	Issue Type +	Ma	Location *	WS
Category	Earthen Levee			GPS Latitude/Longitude	
				Start	End
Item	Erosion / Bank Caving			39.025460 °	39.025460 °
				-121.800022 °	-121.800022 °
DWR ID	DWR_ST0009_02_f_2016_13				
Comment Code					
E2 : Schedule repair of erosion site prior to the next inspection.					
Inspector Comment					
Erosion around the WS concrete vault.

View of the erosion along the concrete vault.

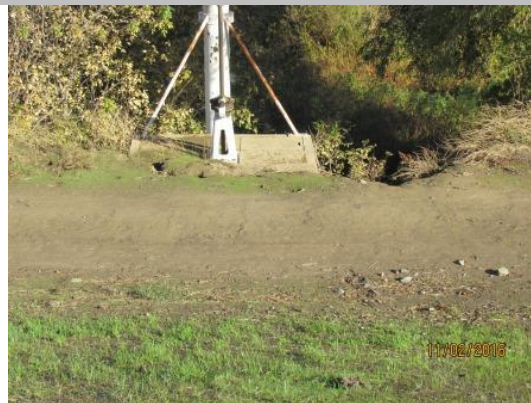
Photo 2 of 2 : SP_2017_ST0009_287_13_20170315_00006.jpg

LM Start	1.14	Rating **	M	Issue No.	13 (cont)	
LM End	1.14	Issue Type +	Ma	Location *	WS	
Category	Earthen Levee			GPS Latitude/Longitude		
				Start		End
Item	Erosion / Bank Caving			39.025460 °		39.025460 °
				-121.800022 °		-121.800022 °
DWR ID	DWR_ST0009_02_f_2016_13					
Comment Code						
E2 : Schedule repair of erosion site prior to the next inspection.						
Inspector Comment						
Erosion around the WS concrete vault.

Another view of the erosion along the concrete vault.

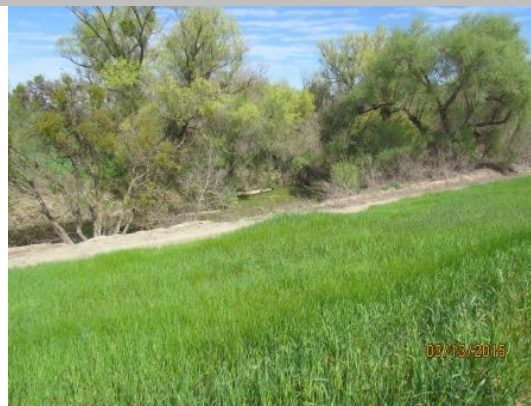
Photo 1 of 1 : SP_2017_ST0009_287_290_20170315_00007.jpg

LM Start	1.19	Rating **	M	Issue No.	290
LM End	1.19	Issue Type +	Ma	Location *	WS
Category	Earthen Levee			GPS Latitude/Longitude	
				Start	End
Item	Erosion / Bank Caving			39.025490 °	39.025490 °
				-121.799240 °	-121.799240 °
DWR ID	DWR_ST0009_02_s_2015_290				
Comment Code					
E1 : Note and monitor erosion site.					
Inspector Comment					
Sutter Yard needs to monitor the erosion along the berm.

View of the erosion along the waterside berm.

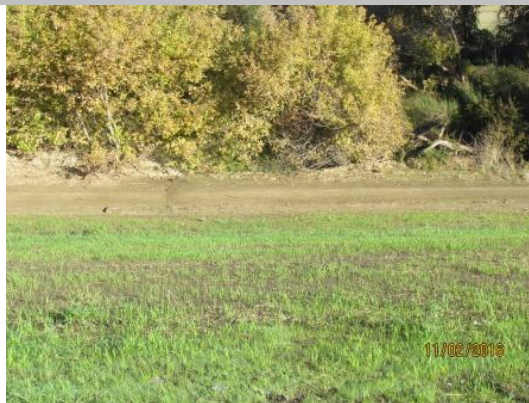
Photo 1 of 1 : SP_2017_ST0009_287_5_20170315_00004.jpg

LM Start	1.48	Rating **	M	Issue No.	5
LM End	1.50	Issue Type +	Ma	Location *	WS
Category	Earthen Levee			GPS Latitude/Longitude	
				Start	End
Item	Erosion / Bank Caving			39.025460 °	39.025446 °
				-121.793815 °	-121.793347 °
DWR ID	DWR_ST0009_02_s _ 2013_5				
Comment Code					
E2 : Schedule repair of erosion site prior to the next inspection.					
Inspector Comment					
Sutter Yard needs to monitor the erosion.

View of the erosion along the waterside berm.

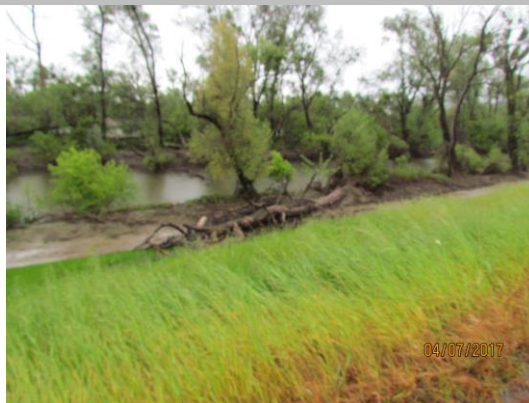
Photo 1 of 1 : SP_2017_ST0009_287_12_20170410_00018.jpg

View of the tree along the waterside slope and toe.

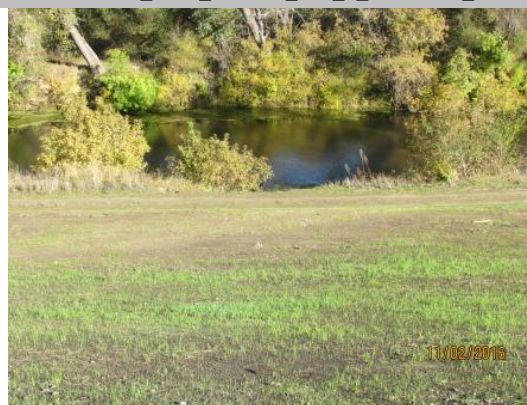
Photo 1 of 1 : SP_2017_ST0009_287_2_20170315_00002.jpg

View of the erosion along the waterside berm.

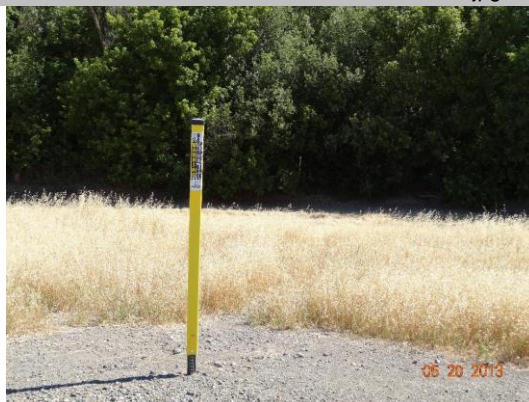
Photo 2 of 3 : UCIP_SP_2017_51491_64680.jpg

Marker on WS shoulder
